Neutral Citation Number: [2020] EWHC 2604 (Admlty)

**IN THE HIGH COURT OF JUSTICE**  
**QUEEN'S BENCH DIVISION**  
**ADMIRALTY COURT**

**Collisions in the Suez Canal, 15 July 2018**

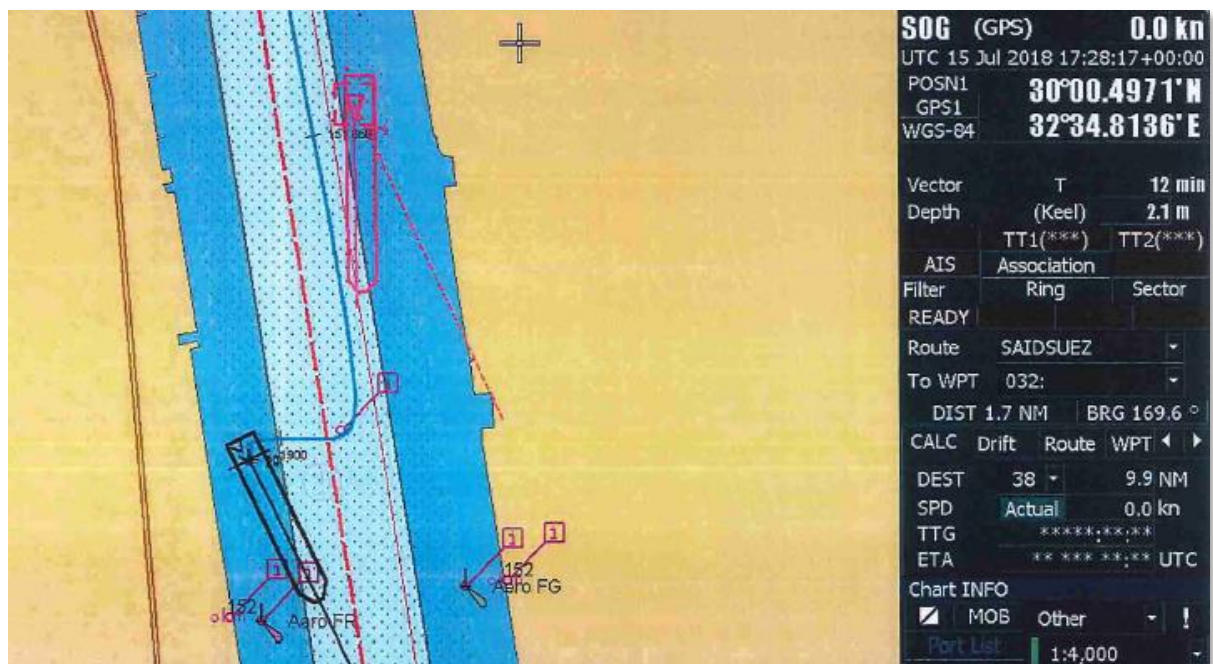
Figure 1 – 19:28LT – OD ECDIS Screenshot of SK and OD before 1st Collision

130. So at 1931 or C-17, whilst SK and OD were stationary, PA still had speed over the ground, about 1.5 knots. Her engines were stopped. Her fair log records that she had had difficulty in mooring. But by this time PA had passed the submarine cables or pipelines south of KM 150 and was free to use her anchors. As just noted the distance between PA and SK had reduced to about 0.5 nautical miles and continued to reduce. The distance between SK and OD was about 2 cables.

131. A screenshot from OD’s ECDIS at 1928 illustrates the positions of SK and OD in the Canal as PA approached them.

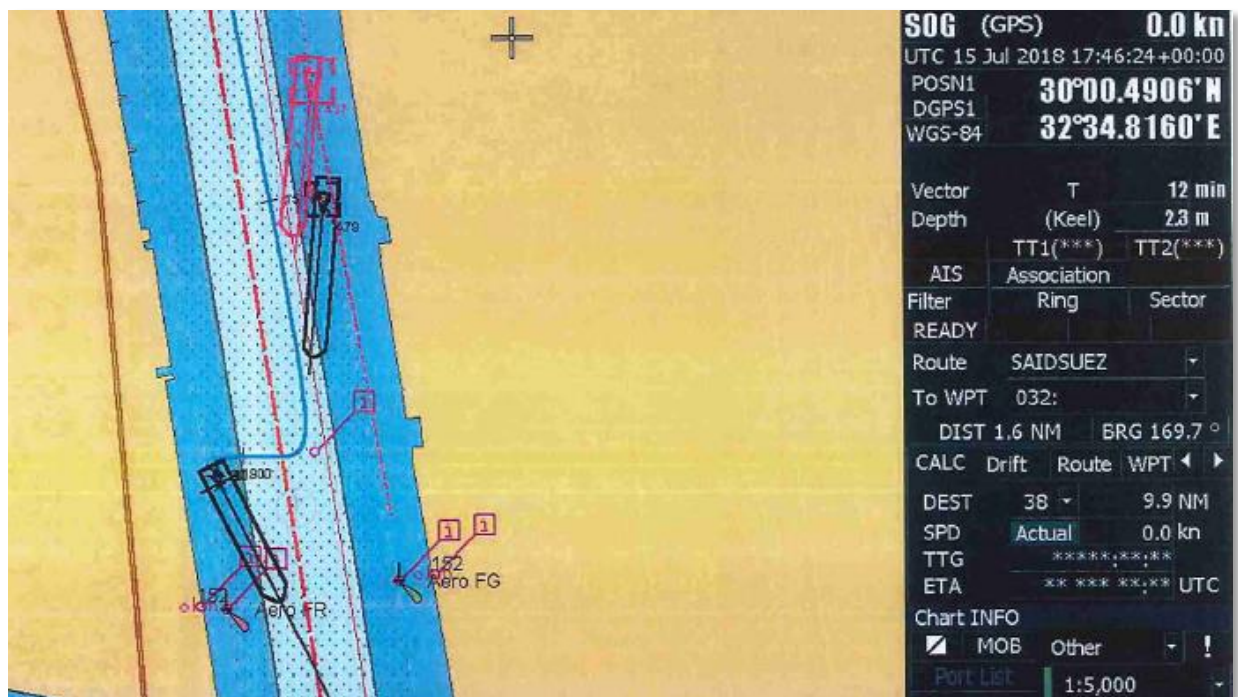
Figure 2 – 19:46LT – **PA** very shortly before first contact with **SK**

135. At 1944 or C-4 the pilot on board SK could be heard saying that PA would hit his vessel. He asked the tug to “*hurry up*”.
136. A screenshot from OD’s ECDIS at 1946 illustrates the position of PA very shortly before the first collision.

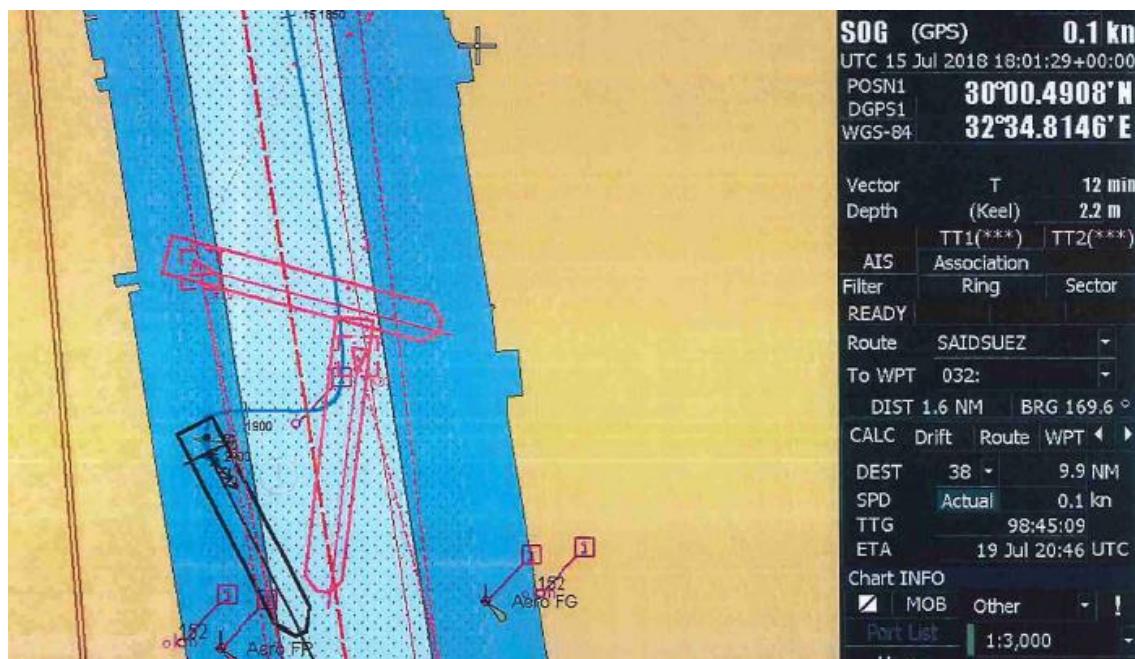
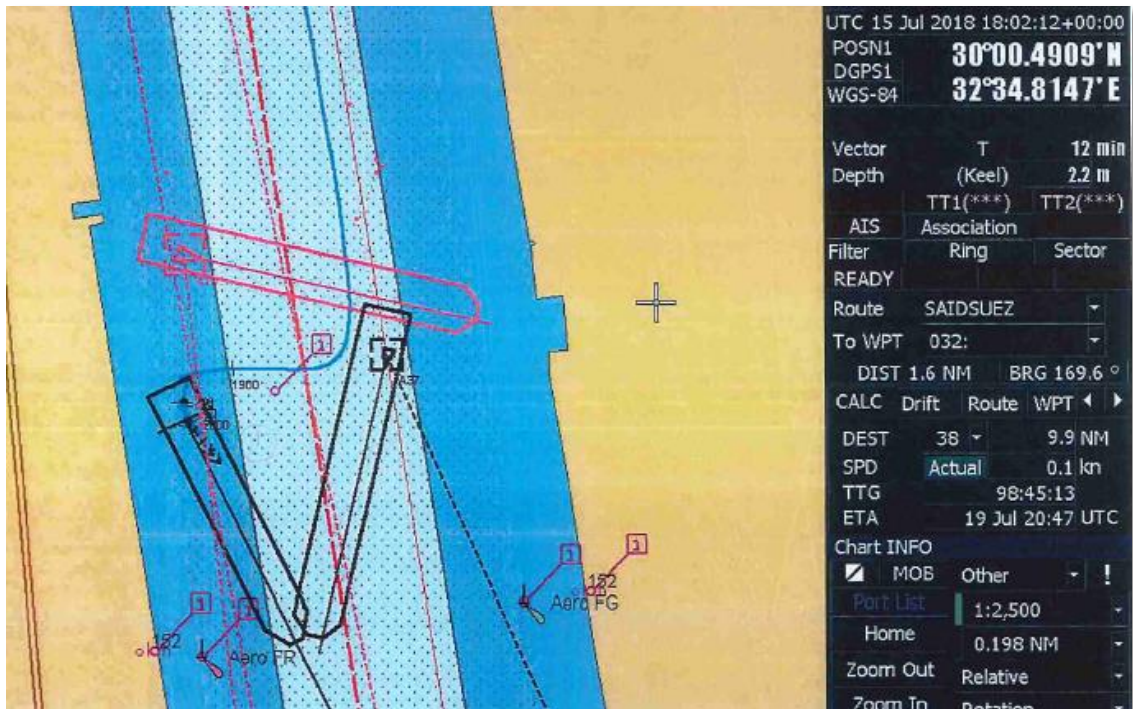
165. Two screenshots from OD’s ECDIS at 2001 and 2002 illustrate the manner in which SK’s stern swung to starboard and PA’s bow moved towards OD.

Figure 3 - 20:01LT

Figure 4 - 20:02LT

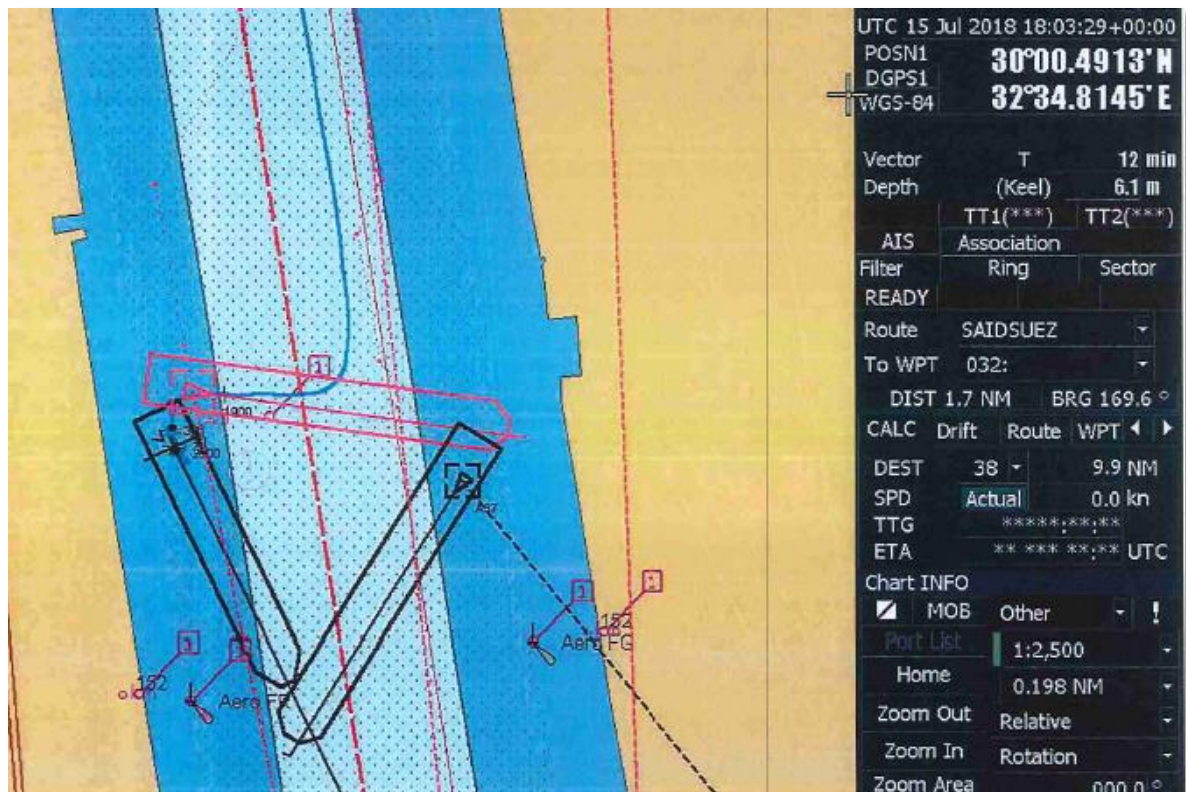
Figure 5 - 20:03LT – The later collisions

166. By about 2003, when SK was heading about 100°, her starboard quarter struck the port quarter of OD. At about the same time, and as recorded in OD's log, PA struck OD on her port side forward. It has been said on behalf of OD that there was contact between OD's railing and PA's starboard hawse pipe which was described on behalf of PA as minor. However, this is not the occasion to determine the extent of damage caused by this collision.
167. A screenshot from OD's ECDIS illustrates the collisions at 2003 and the remarkable triangle formed by the vessels.

168. OD's lines parted, her anchor cable ran out and the three vessels moved slowly down the Canal (in the form of a triangle until about 2007-8 when the stern of SK fell astern of the stern of OD).

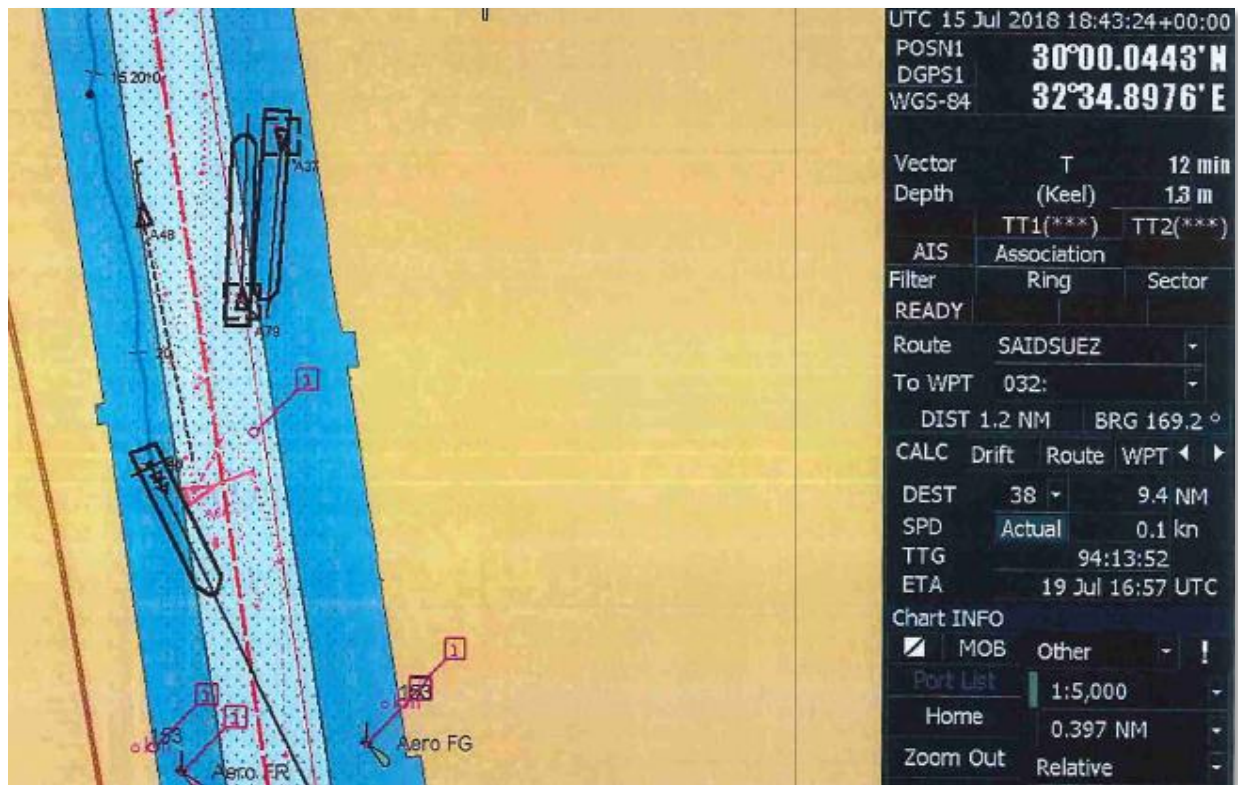
Figure 6 - from 20:25LT - All vessels stopped

172. At about 2014 there was a second contact between the starboard quarter of SK and the port quarter of OD.
173. By this time the triangle of vessels had reformed.
174. By about 2016-2017 the vessels had separated. SK continued to swing to starboard with the result that, remarkably, PA and SK ended up on the east side of the Canal on reciprocal headings, alongside each other. OD was again on the west side of the Canal, a little ahead. It is accepted by PA that there was further contact between SK and PA at 2018.
175. A screenshot from OD’s ECDIS at 2025 illustrates PA and SK lying on reciprocal headings and OD again on the west bank but now close to KM 153.
