Neutral Citation Number: [2019] EWHC 481 (Admlty)

Case No: AD-2016-000111

(1) ALIZE 1954
(2) CMA CGM SA
- and -

ALLIANZ ELEMENTAR VERSICHERUNGS AG
AND OTHERS

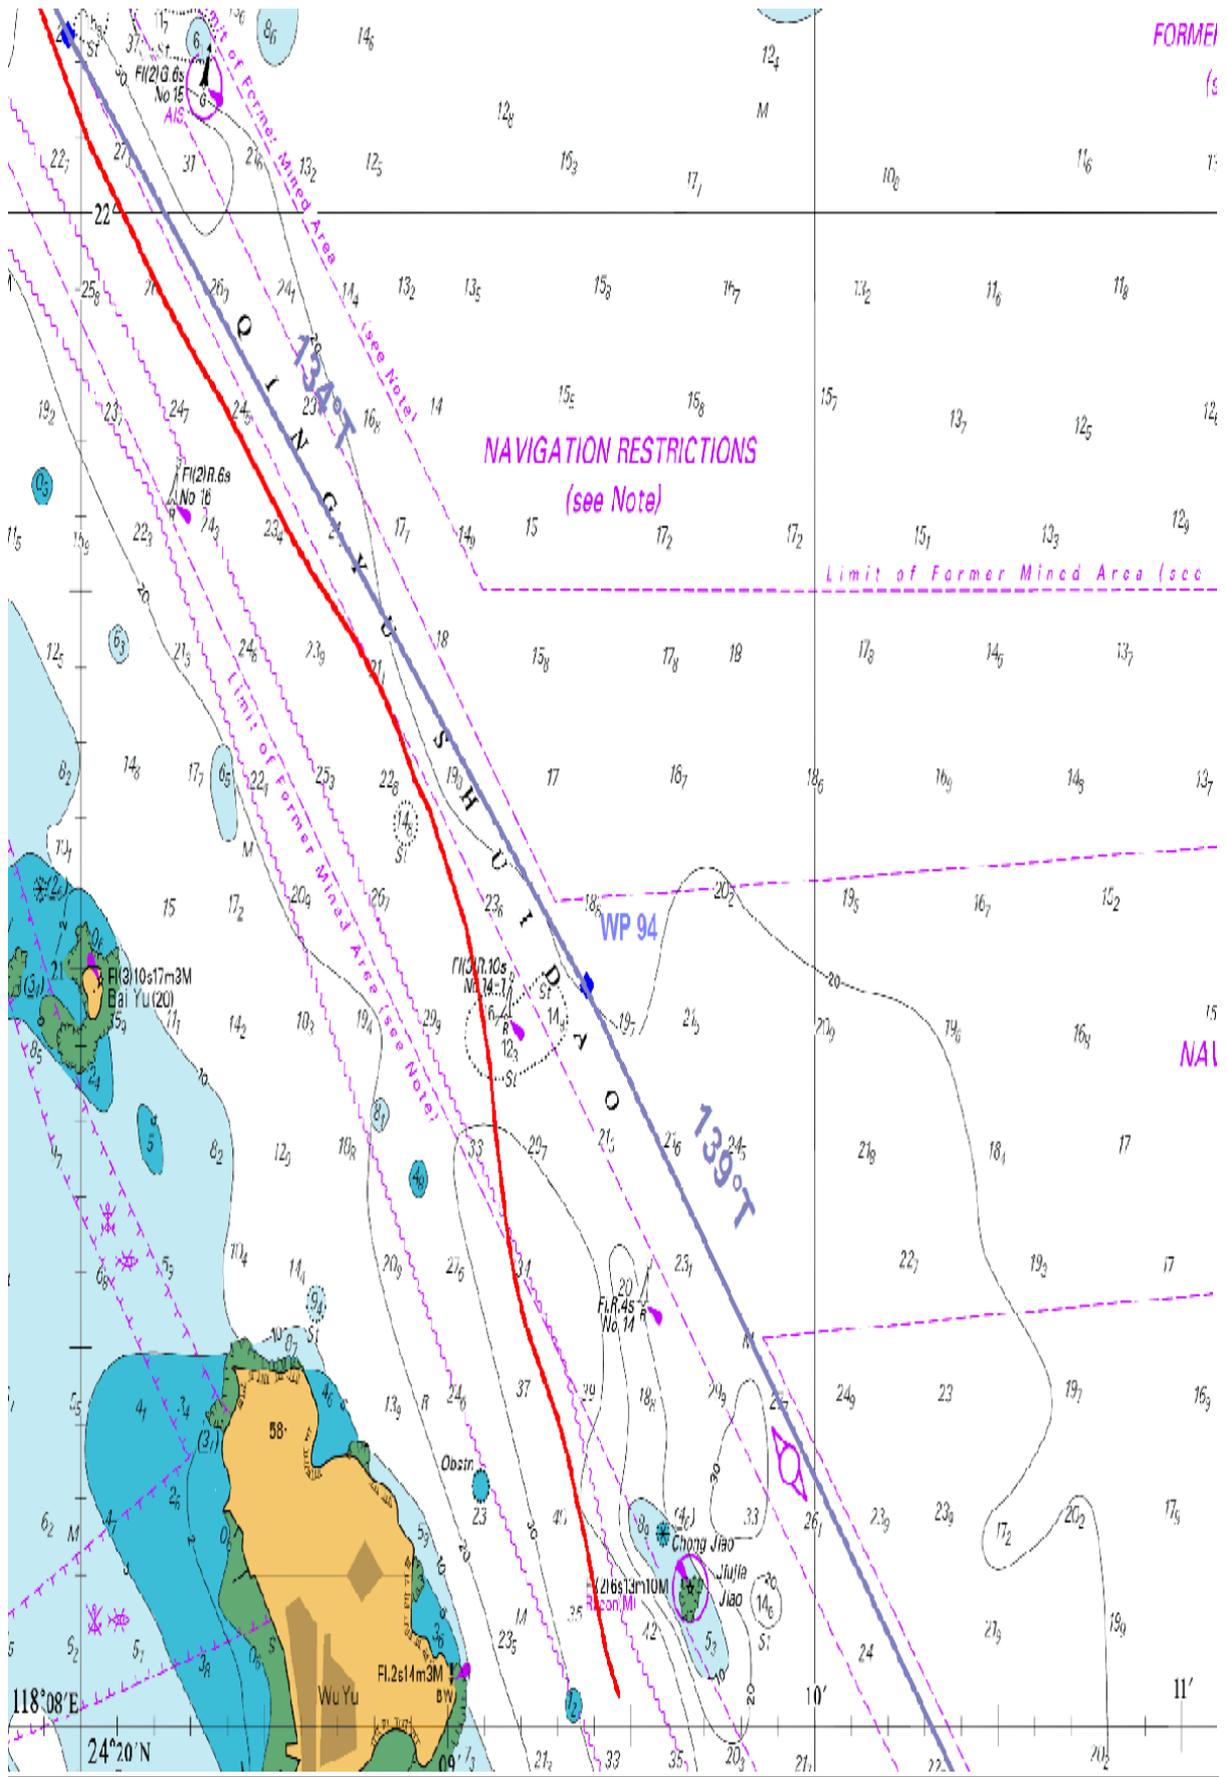
CHART EXTRACT

22. Shortly before 0235 on 18 May 2011 the vessel grounded whilst leaving Xiamen. She was about 4 cables to the west of the buoyed fairway in an area where there were charted depths of over 30 metres. She was between the rocks of Juijie Jiao (which were under 2 cables to the west of the buoyed channel) and the sounding of 1.2 metres newly marked on the 30 metre contour. The latter sounding was less than a cable to starboard of the vessel.

23. The paper Admiralty chart did not indicate the shoal on which the vessel grounded (though the sounding of 1.2 metres which was added to the chart in April 2011 might have been part of that shoal). However, there is evidence that the shoal on which the vessel grounded was marked on an amendment to the ENC (cell C1514291) which was issued on 13 January 2011 by the Hydrographic Office. But the vessel did not carry (and was not required by SOLAS to carry) ENC charts.
